Site 181 Good Harbor Beach

Great Marsh Coastal Wetlands Restoration Plan
Rapid Technical Assessment Site 181

Site # 181
Good Harbor Beach

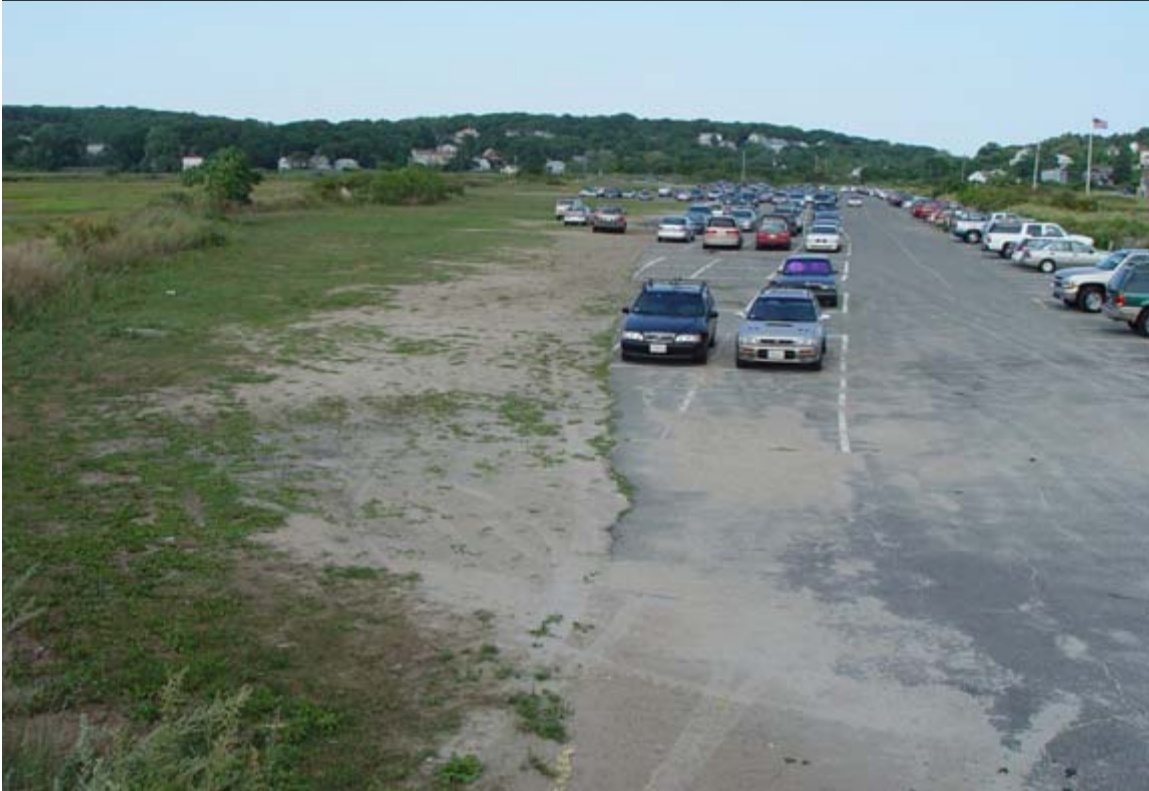
Photo 1 - Parking Lot and Restoration Area Viewing Northeast

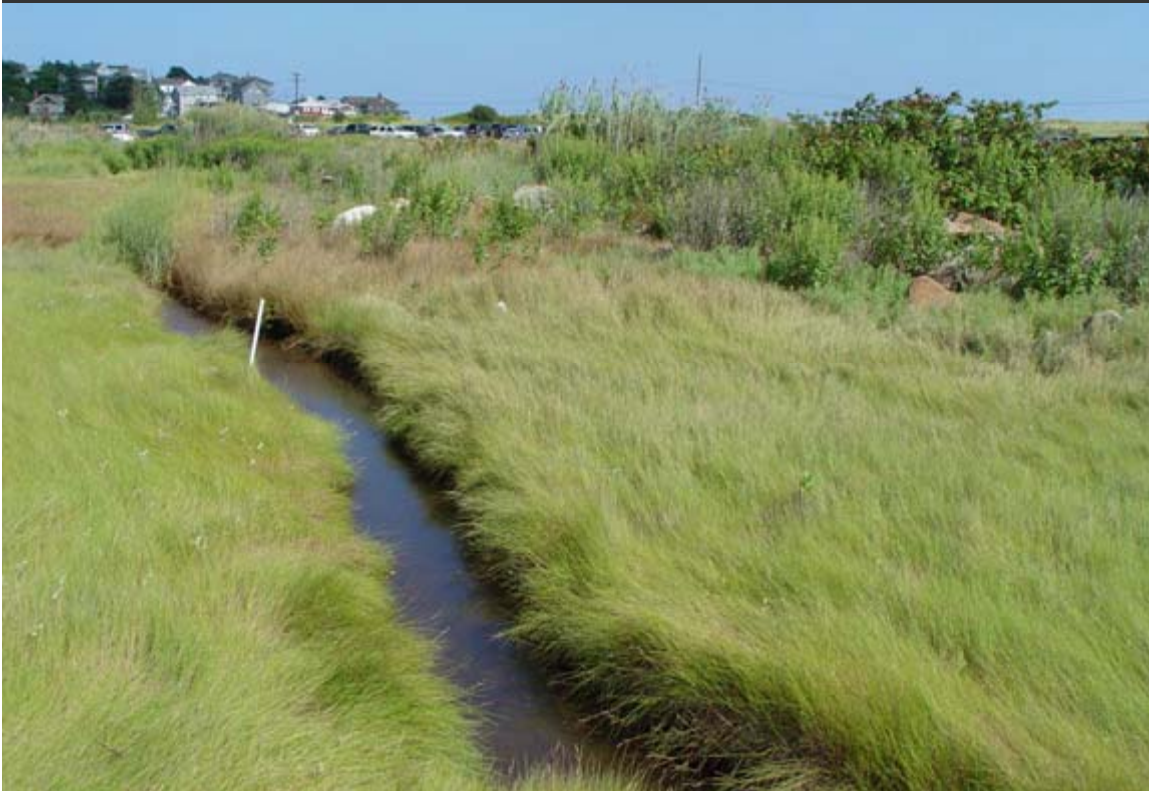
No tide data was collected for the site. Currently there is only a single ditch approximately 3 ft wide and 1.2 ft in deep draining from the restoration area. The drainage channel splits into two

remnant ditches which extend into the low-lying portion of the fill site. The overall severity of the existing impairments within the fill site is considered severe. Removal of the fill material to near or slightly below the adjacent marsh elevation will restore salt marsh vegetation and lost flood storage volume. The restoration effort would include the removal of a portion of the existing fill, creation of a small creek system to encourage good tidal exchange, plantings, and adjacent infrastructure improvements to elevate and resurface the parking facilities. A partial restoration of approximately 2 ac is possible without substantially impacting existing parking spaces. Reconstruction of the parking area could also improve stormwater quality and reduce flooding and saturation problems within the low-lying parking areas. There are no important habitat values or adjacent properties which would be adversely impacted by the restoration activity. The restoration would also address the current populations of invasive species found along the leading edge of the fill. The City is currently initiating a Beach Management Plan which should include better operational practices for the handling of debris removed from the beach.

Photo 2 - Ditch Leading into Low-Lying Portion of Site along Fill Edge

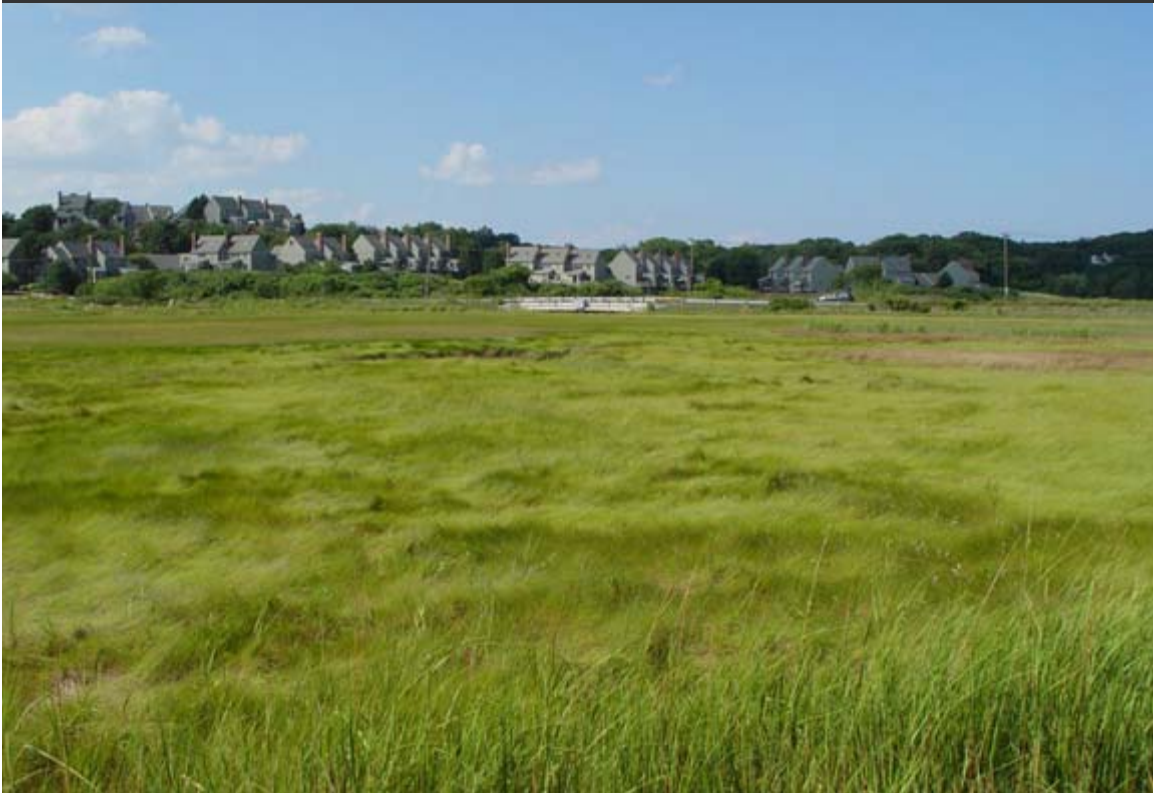
There is a pronounced reduction in the number and frequency of parallel grid ditches within the salt marsh adjacent to the restoration area in comparison to the marsh on the opposite side of the main creek. There are also several connected shallow pools with radial ditching which are the result of past OMWM practices in the early 1980's. Shallow peat over sand within the salt marsh causes the pannes to drain too quickly (W. Montgomery, Superintendent, NE MA MWMD). The area is not contained within an ACEC, BioMap designations, or listed species habitat. The main creek is mapped as suitable habitat for soft shell clam and the beach front is mapped as suitable habitat for surf clam. The entire barrier beach and salt marsh complex south of the Route 127A corridor is municipally-owned. Land uses along the Route 127A corridor include high density residential and commercial.

Photo 3 - Adjacent Marsh Viewing North

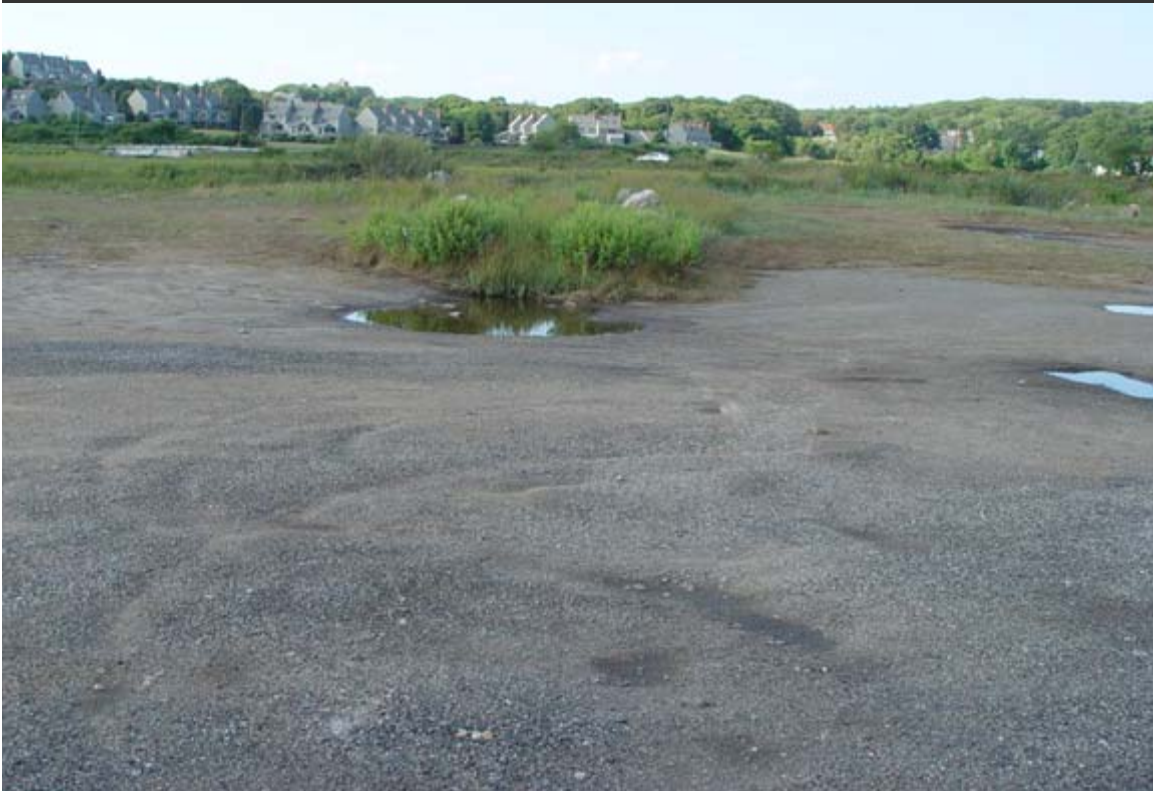
Photo 4 - Remnant Ditch Extending into Low-lying Portion of Site

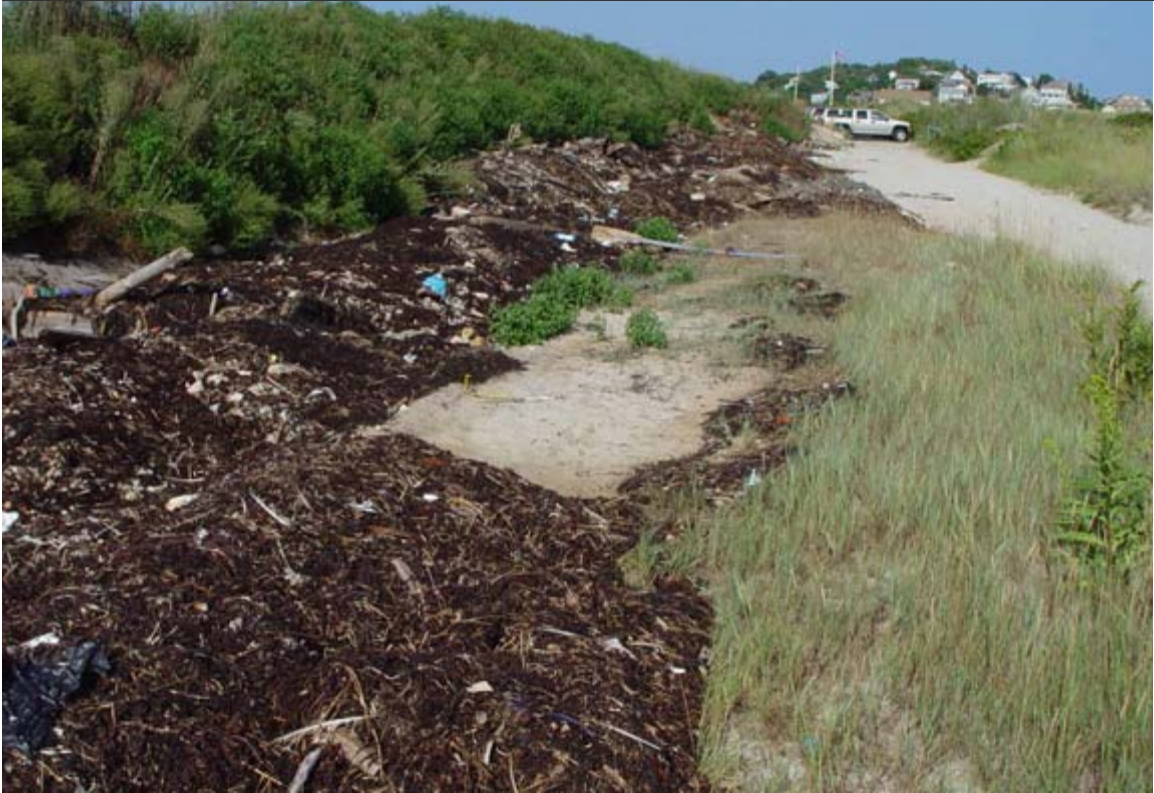
Photo 5 - Stockpile of Debris from Beach Cleaning
